Historic Furnishings Report Painted Desert Inn

Volume 1: Historical Data
Volume 2: Implementation Plan

Petrified Forest National Park
Petrified Forest, Arizona

**Northeast Museum Services Center
National Park Service
May 2004**

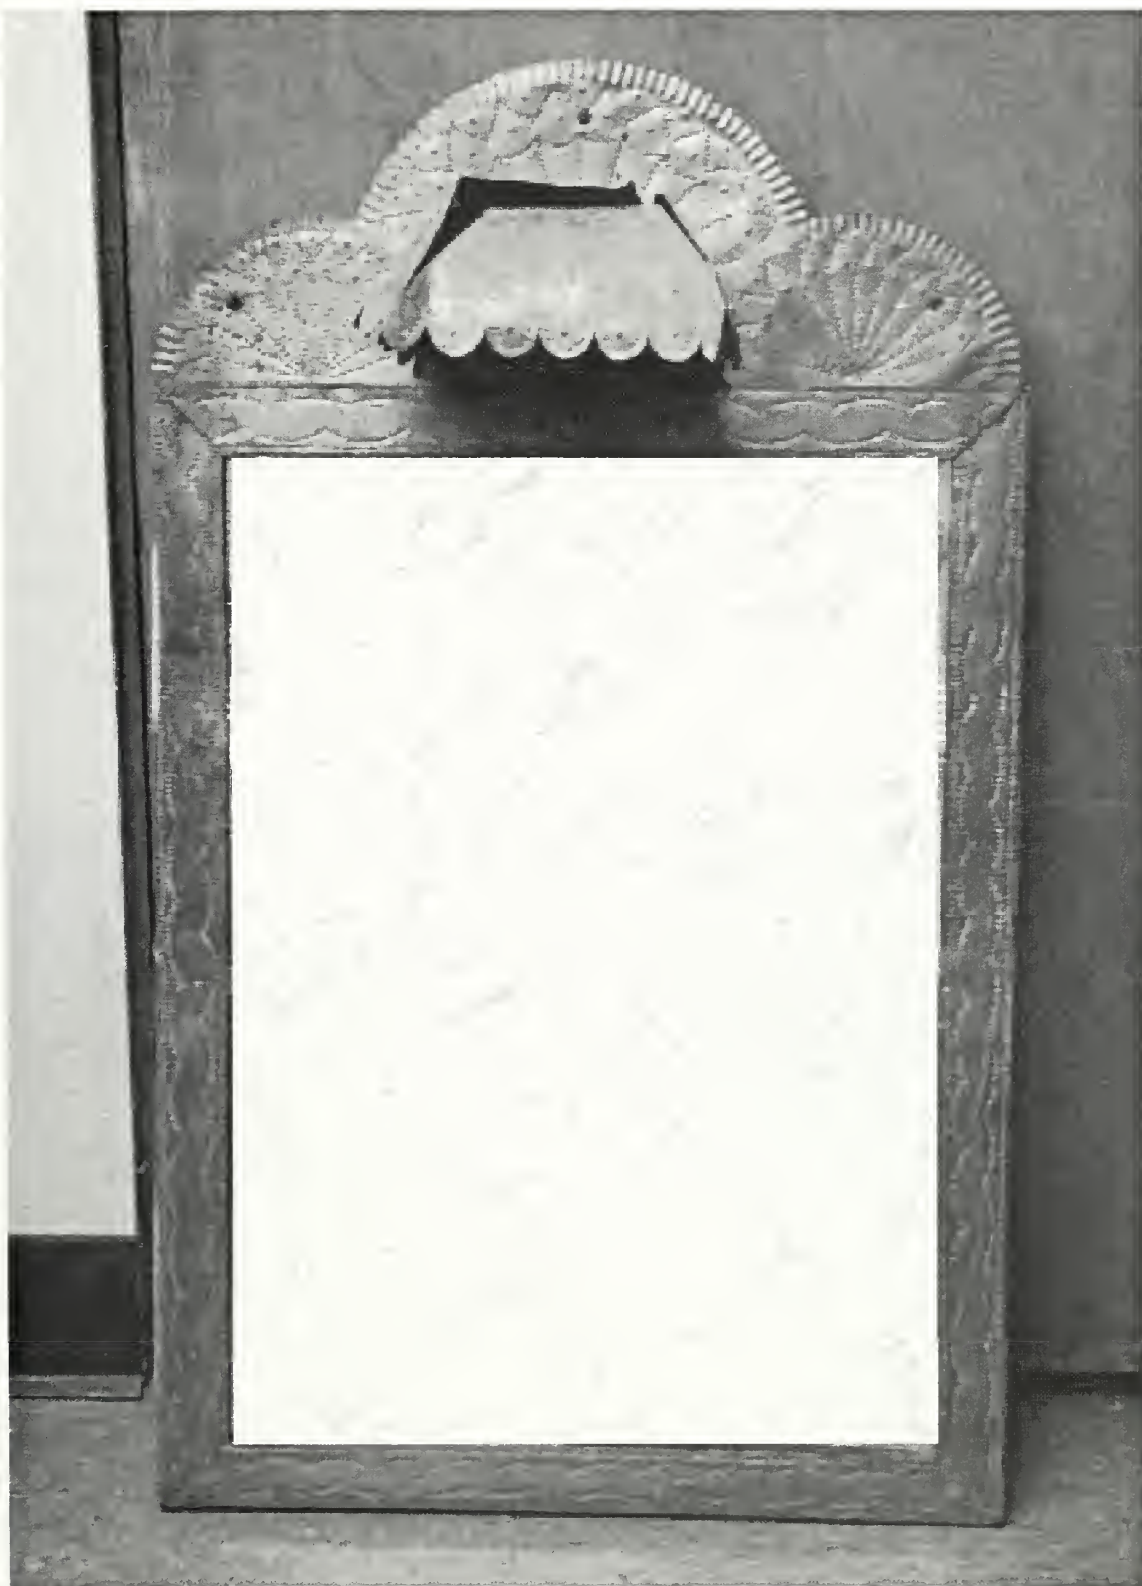
21. "Stamped Tin Mirror, Design by Lyle Bennett, 1938." 2002,
Photograph by Laura DeNormandie.

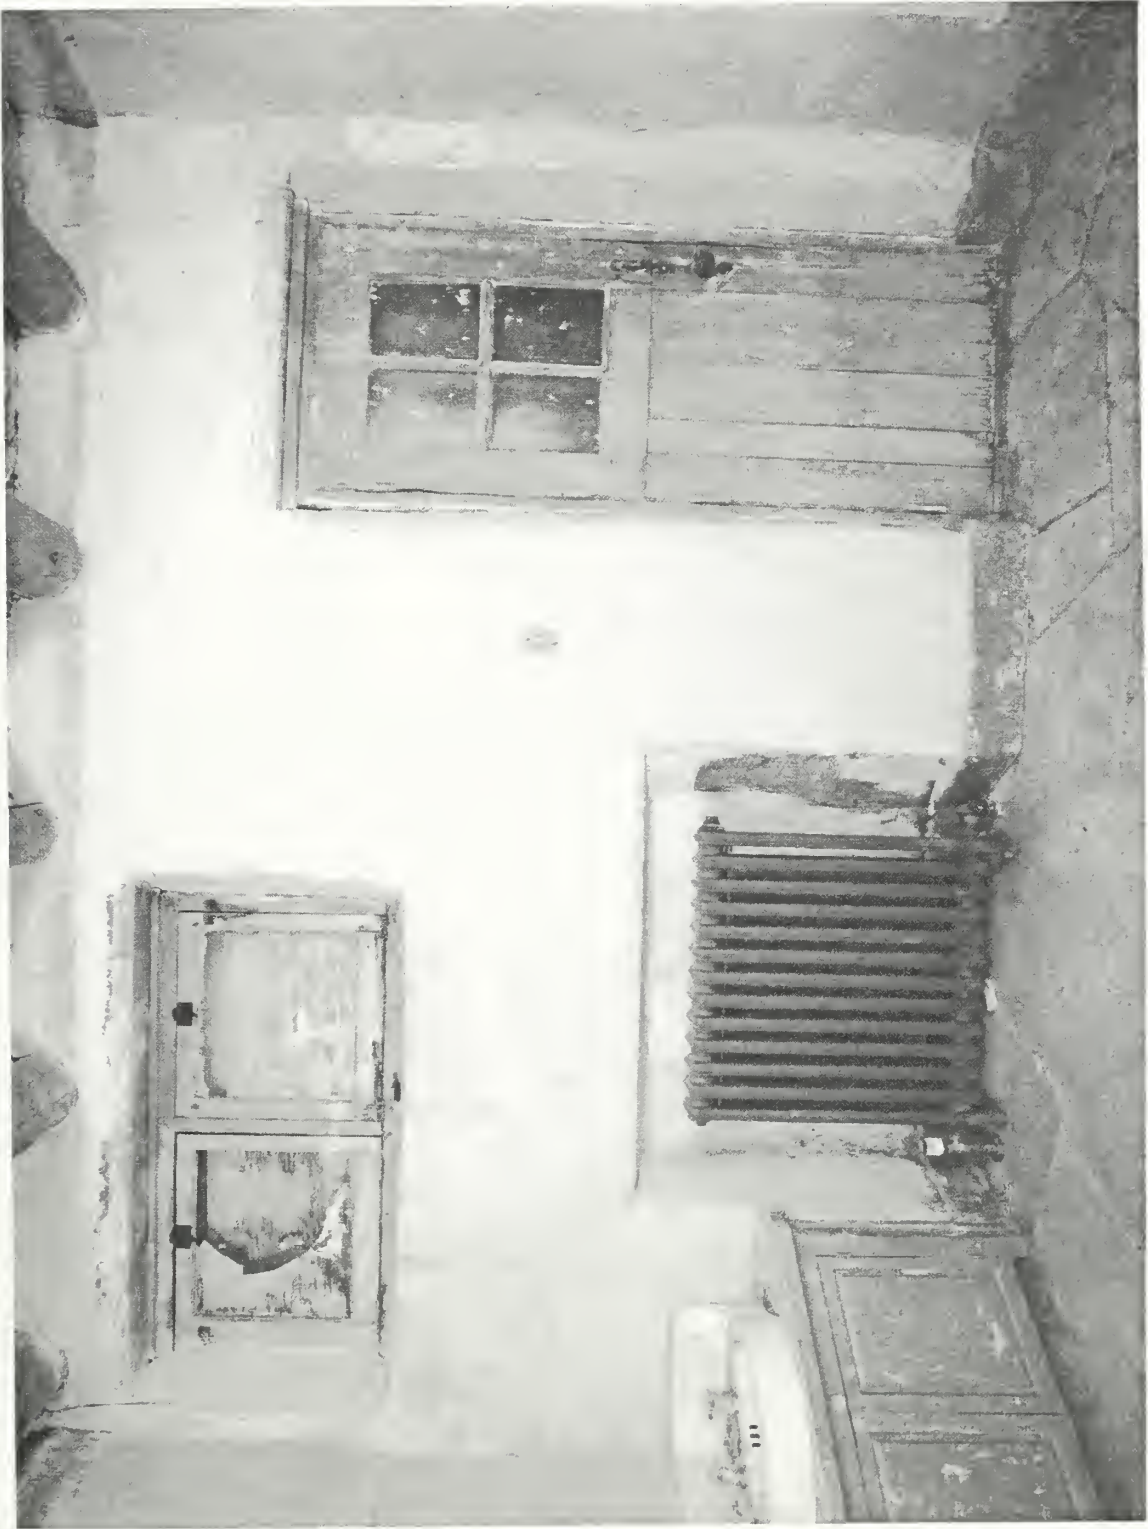
22. "Sink and Cabinet, (Room 12)." 1992, Photograph by Historic American Buildings Survey, Design by Lylè Bennett, Museum Collection, Archives, Petrified Forest National Park, Petrified Forest, Arizona, No. PD-87a; HABS: AZ-161-87.

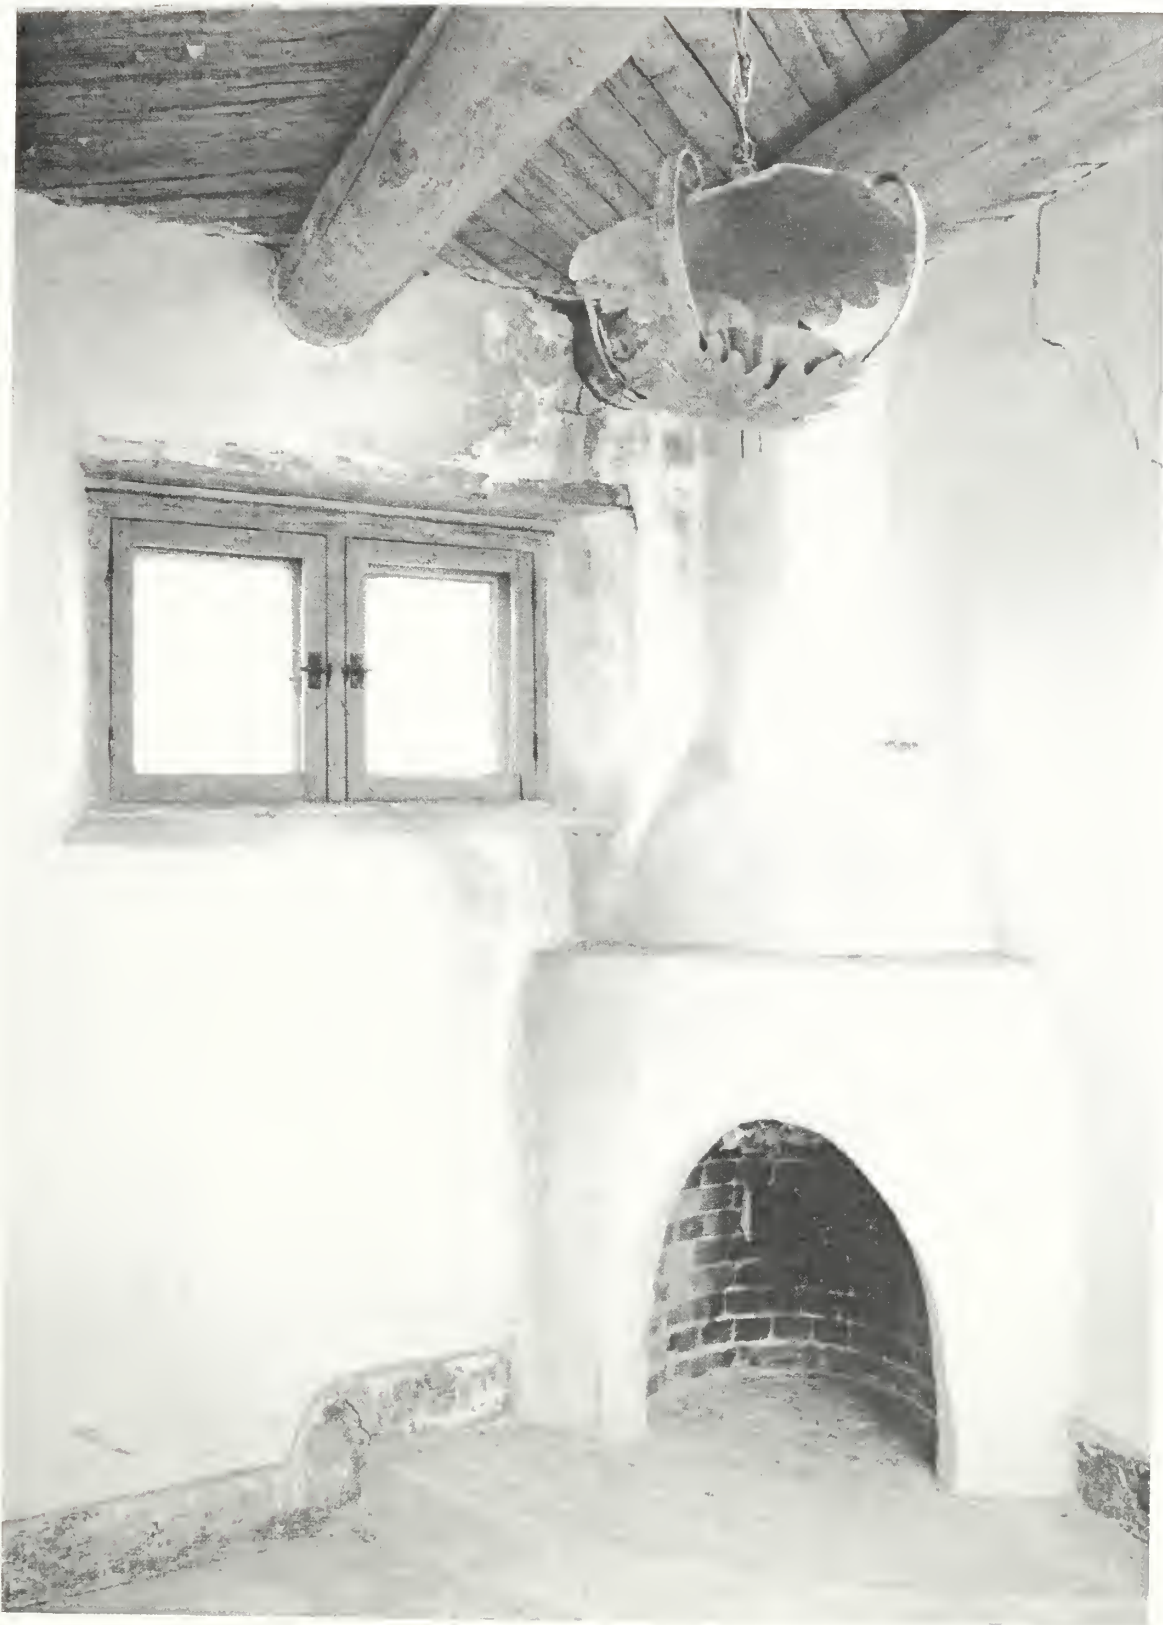
23. "Fogon or Beehive Fireplace, with Stamped Tin Lighting Fixture, (Room 10)." 1992, Photograph by Historic American Buildings Survey, Design by Lyle Bennett, Museum Collection, Archives, Petrified Forest National Park, Petrified Forest, Arizona, No. PD-90; HABS: AZ-161-90.

One tin lighting fixture in the lunchroom has been conserved. Others that currently hang in the Painted Desert Inn dining room, lunchroom, trading post room, ranger room, and guest room are intact but need to be assessed in terms of condition. Other tin fixtures in storage all need to be conserved and vary in terms of condition. Once conserved, *in situ* extant shelving and furnishings (such as the tap room bar, and fagon fireplaces in the guest rooms) can be used as installation objects.

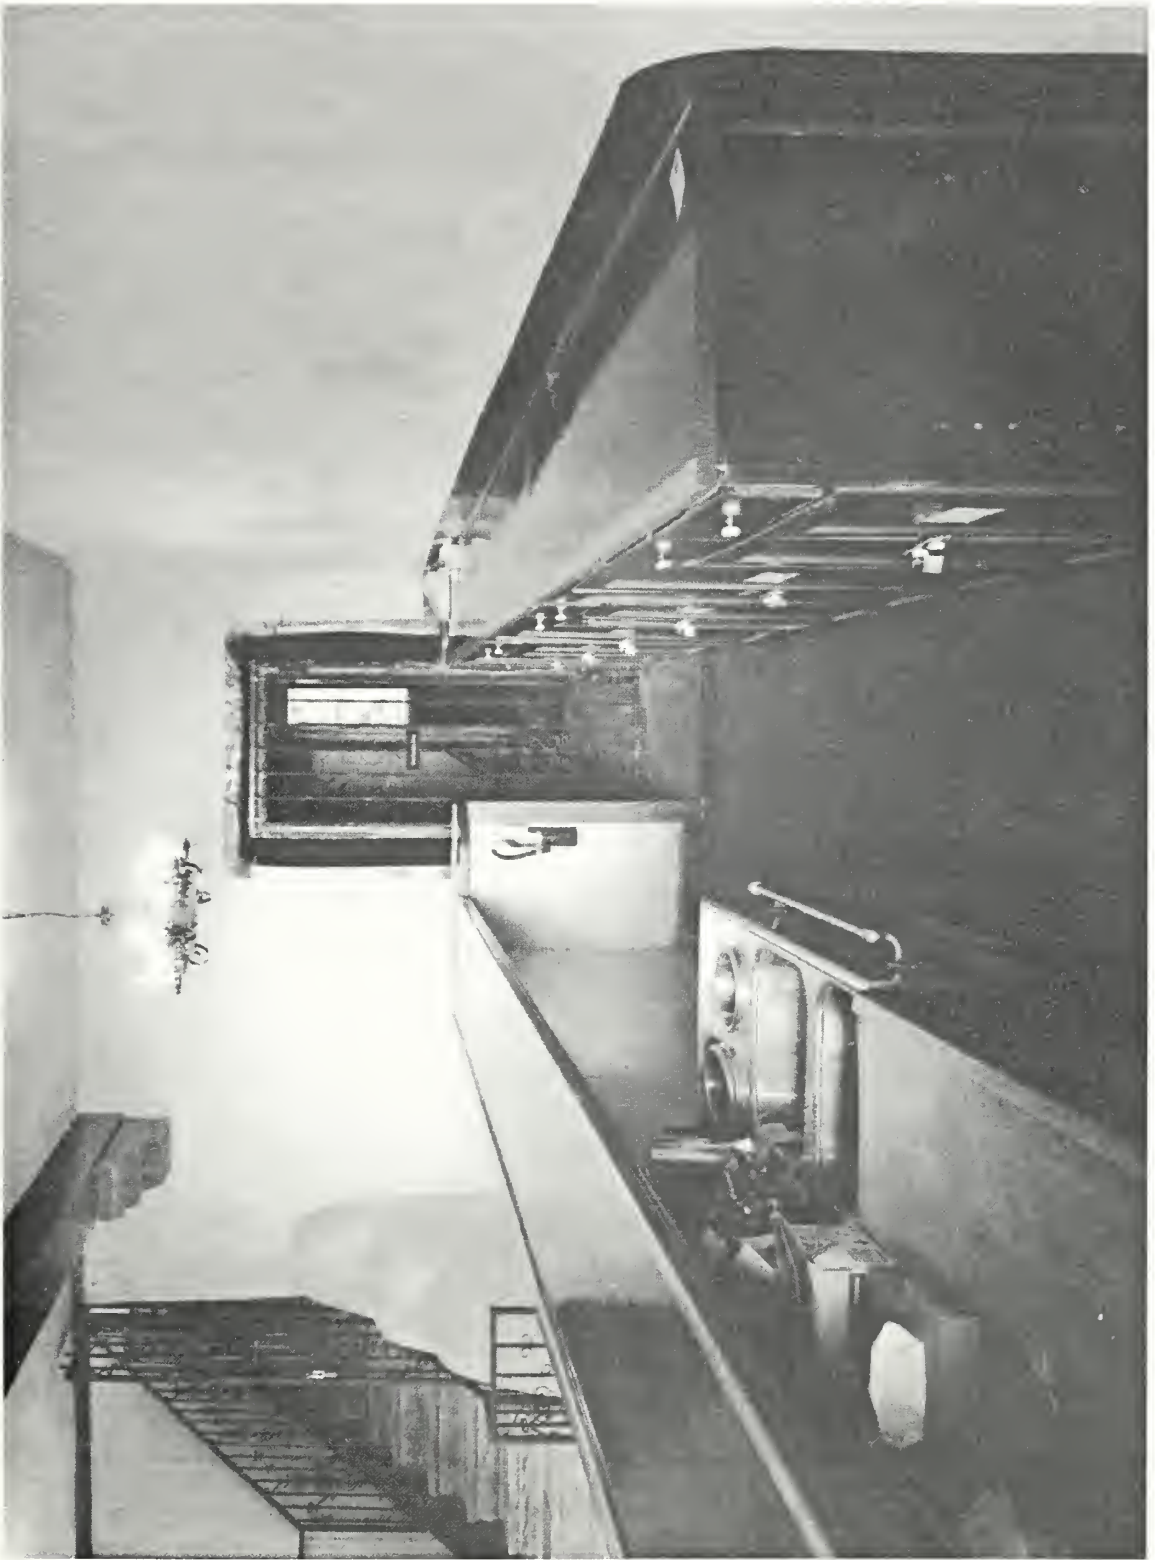
34. "Tap Room, Bar Looking South, (Room 13)." 1992, Photograph by Historic American Buildings Survey, Museum Collection, Archives, Petrified Forest National Park, Petrified Forest, Arizona, No. PD-64; HABS: AZ-161-60.

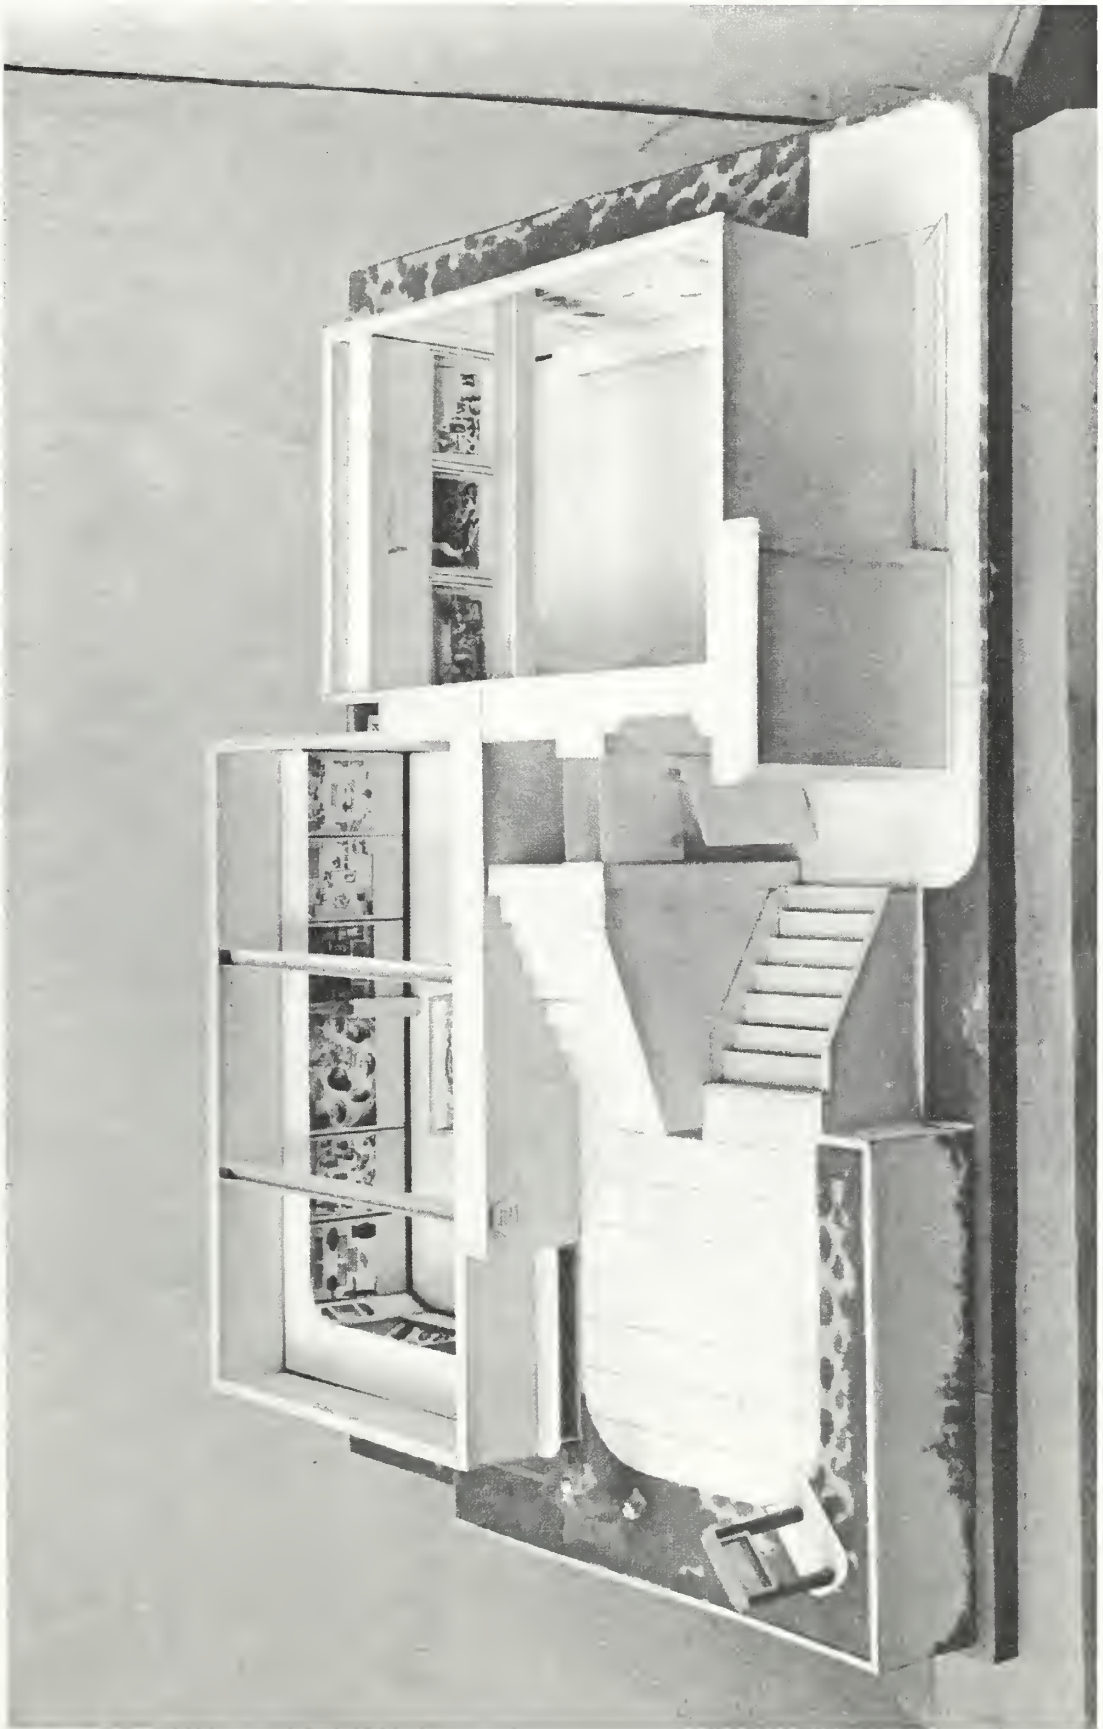
36. "Proposed Scale Model, Painted Desert Inn Museum, (Room 19, Room 20)." February 3, 1941, Unidentified Photographer, Museum Collection, Archives, Petrified Forest National Park, Petrified Forest, Arizona, Negative No. 1215, PEFO CAT. # 20636.

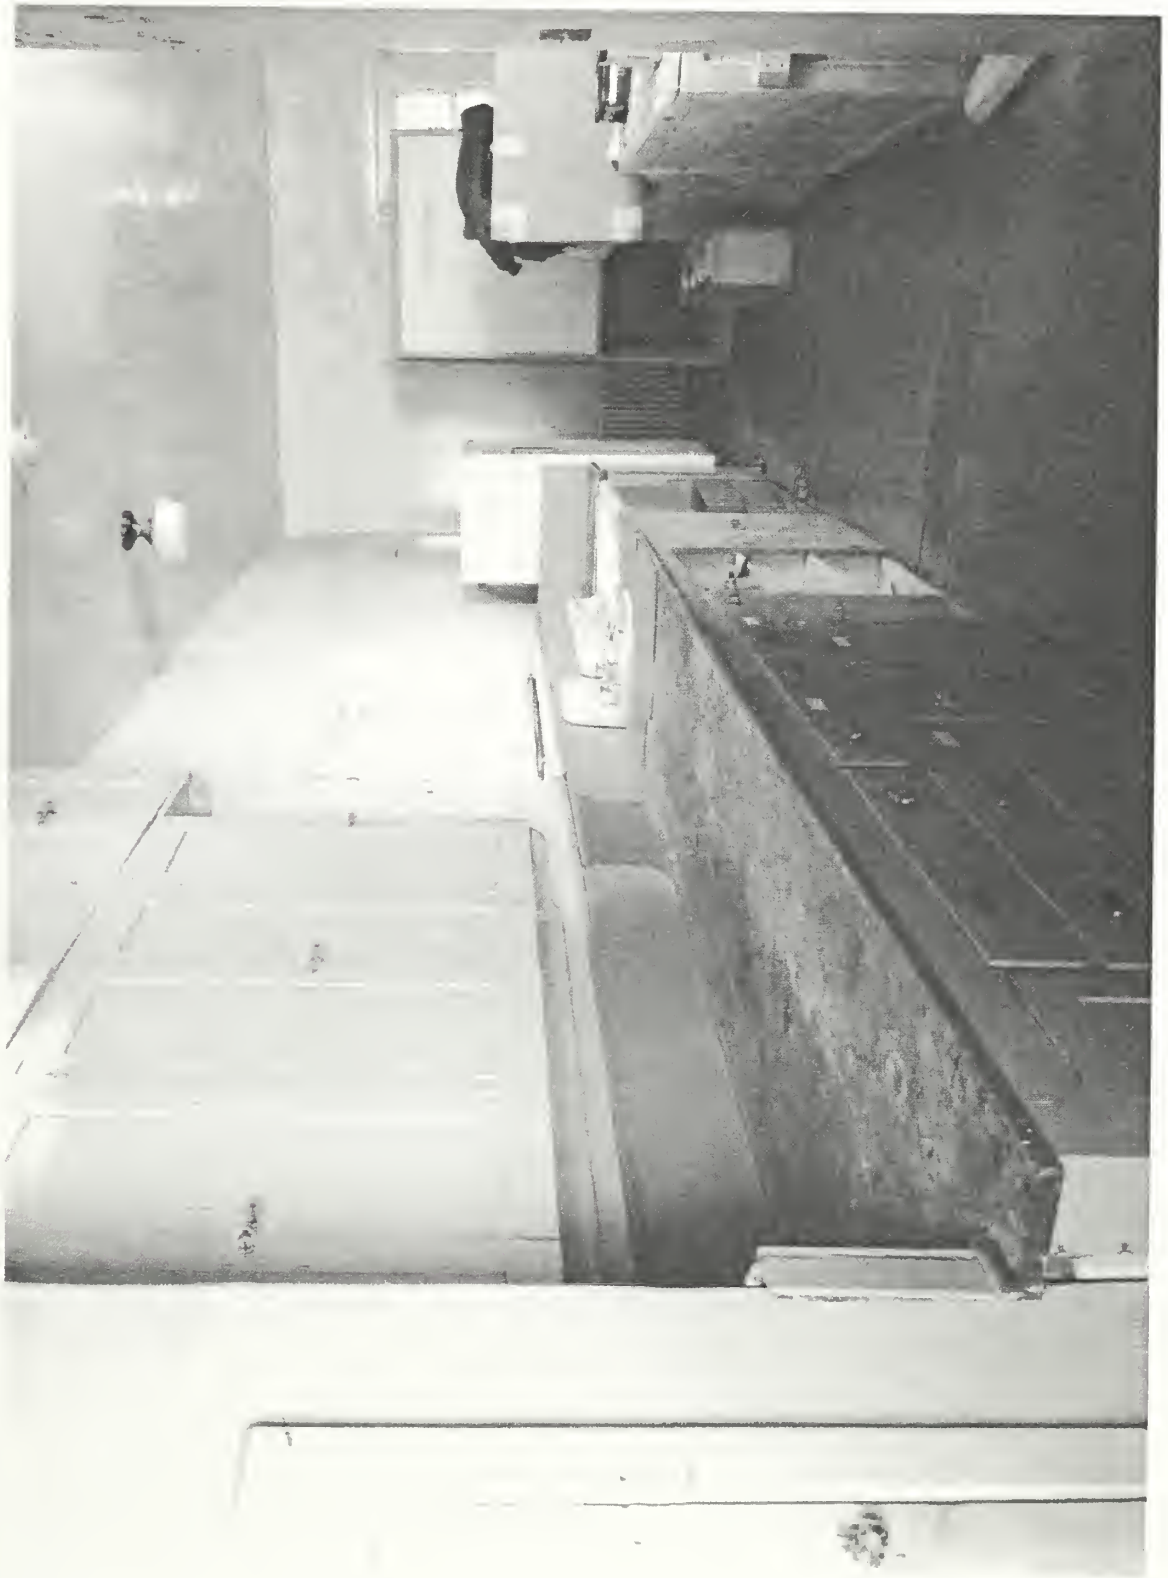
40. "Kitchen, Cabinetry at East Wall, (Room 101)." 1992, Photograph by Historic American Buildings Survey, Museum Collection, Archives, Petrified Forest National Park, Petrified Forest, Arizona, No. PD-58; HABS: AZ-161-54.

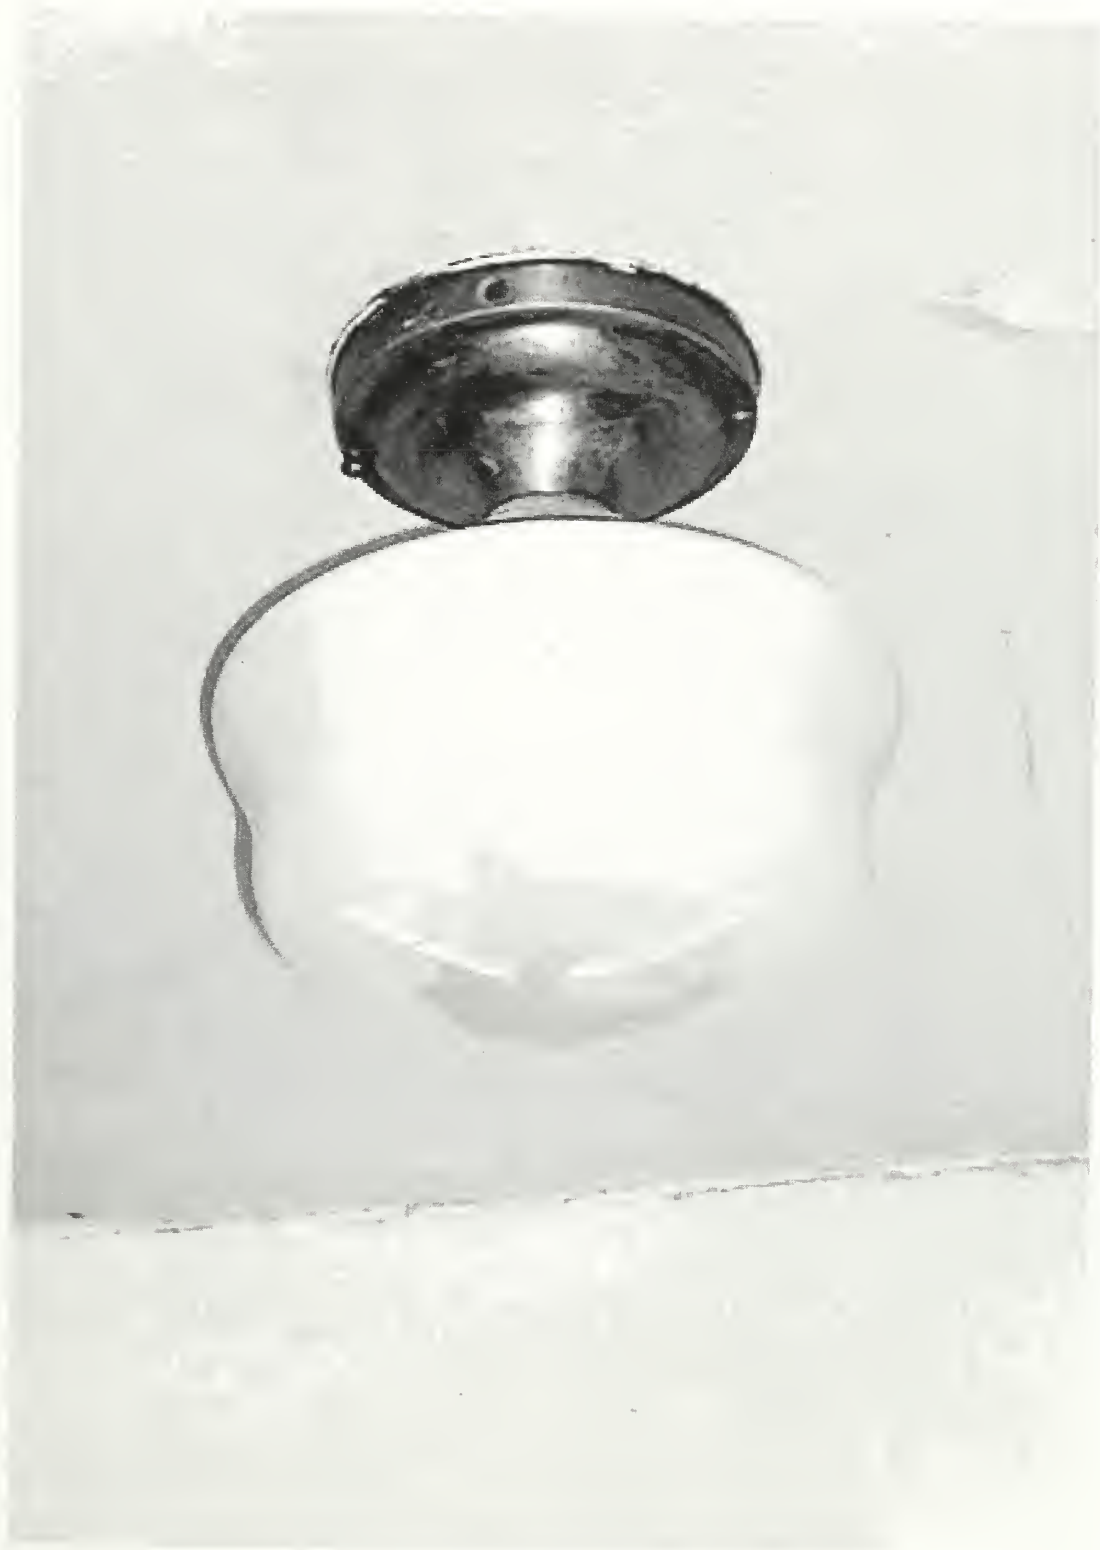
41. "Light Fixture, Kitchen, Circa-1940s or 1950s." 2002, Photograph by
Laura DeNormandie.

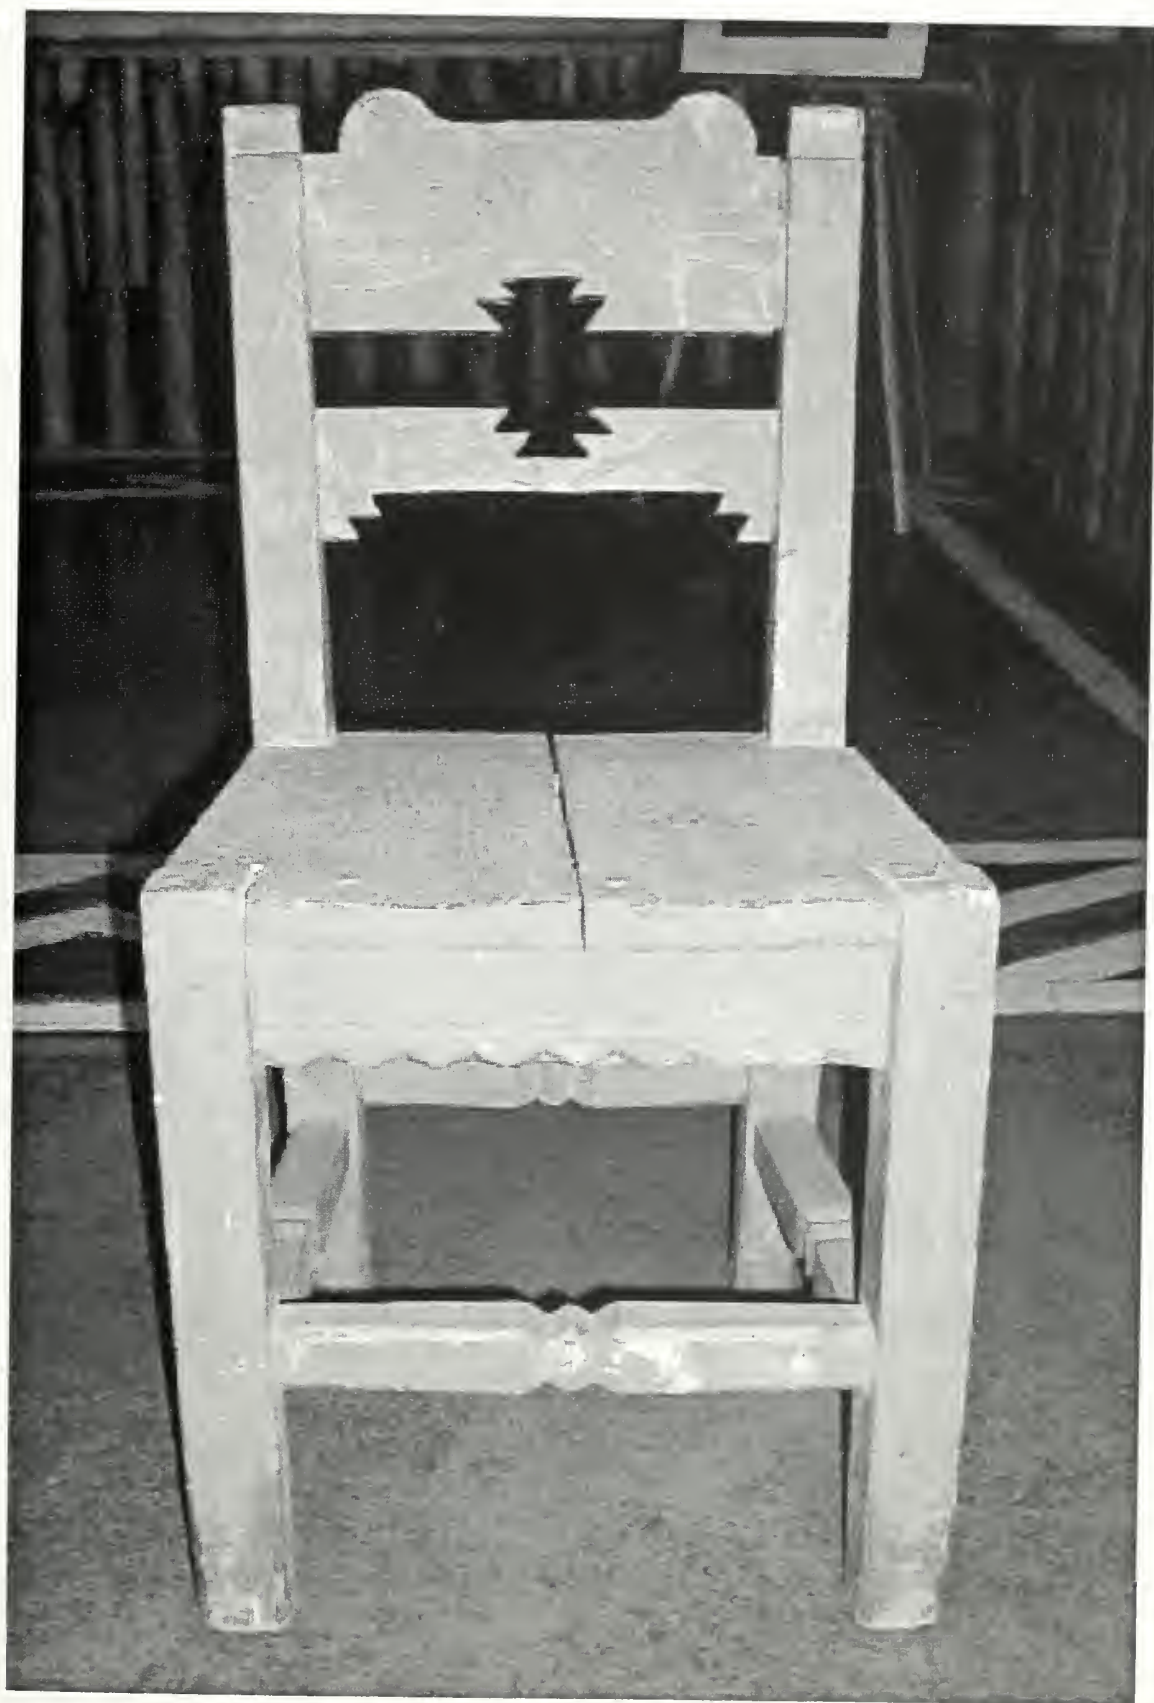
46. "Dining Room Chair, Front Side." 2002, Photograph by Laura DeNormandie.

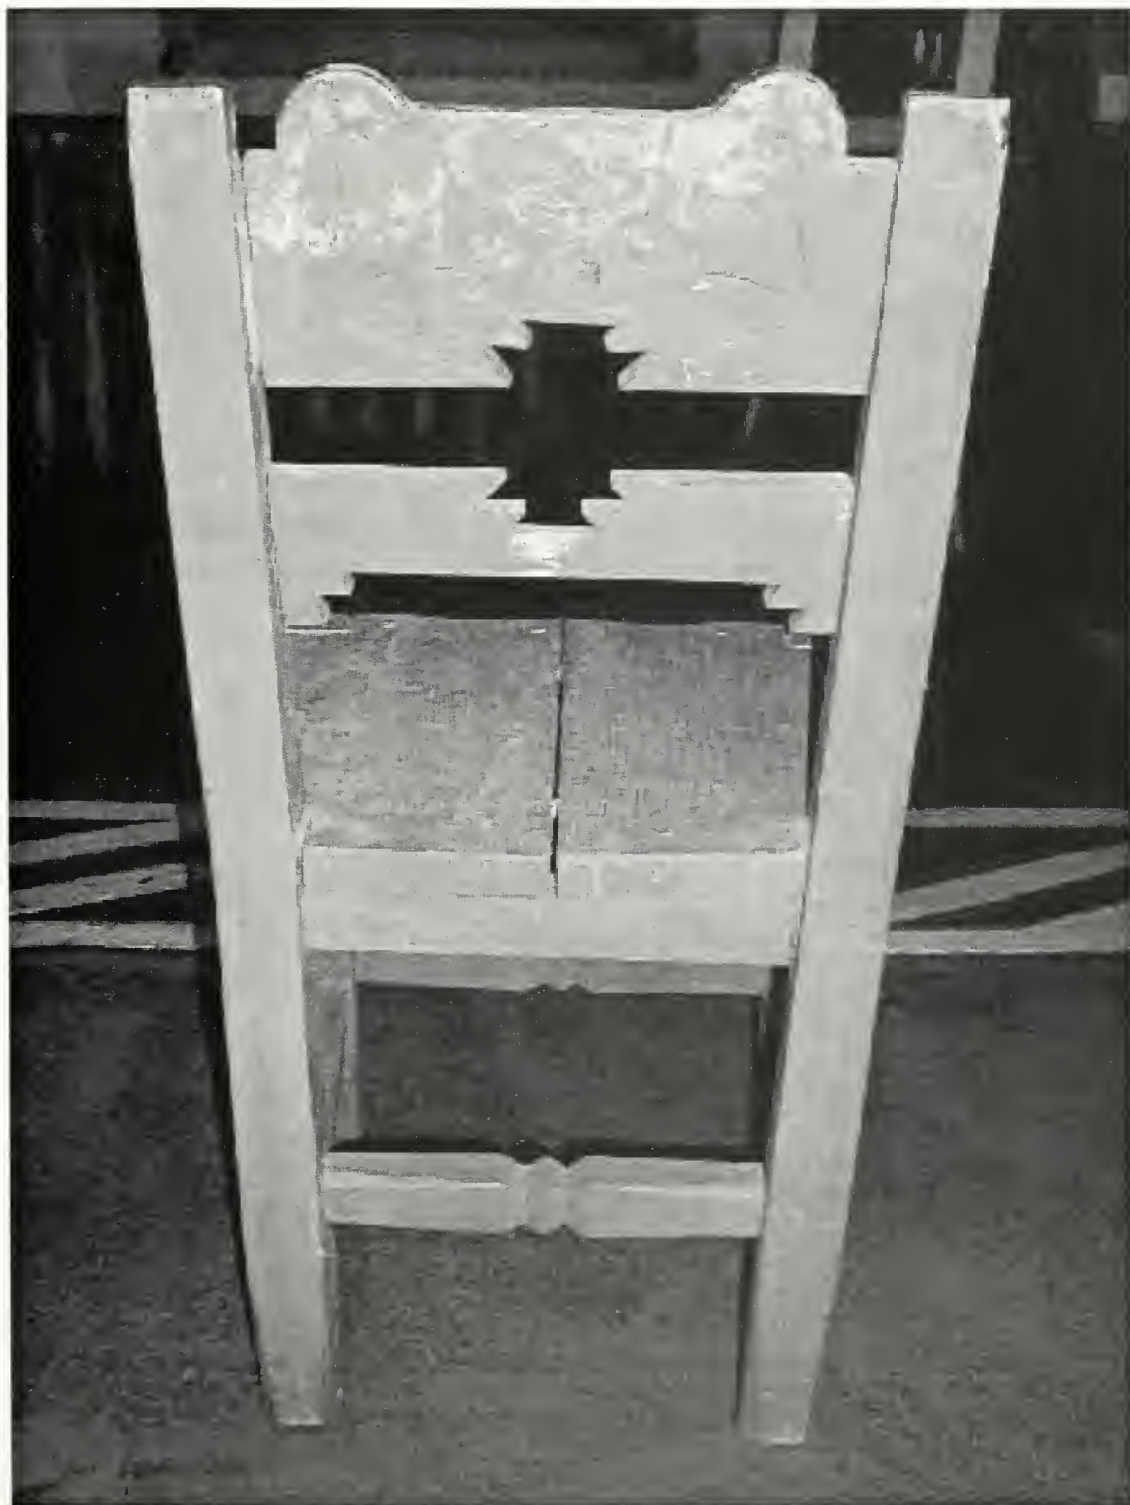
47. "Dining Room Chair, Back Side." 2002, Photograph by Laura DeNormandie.

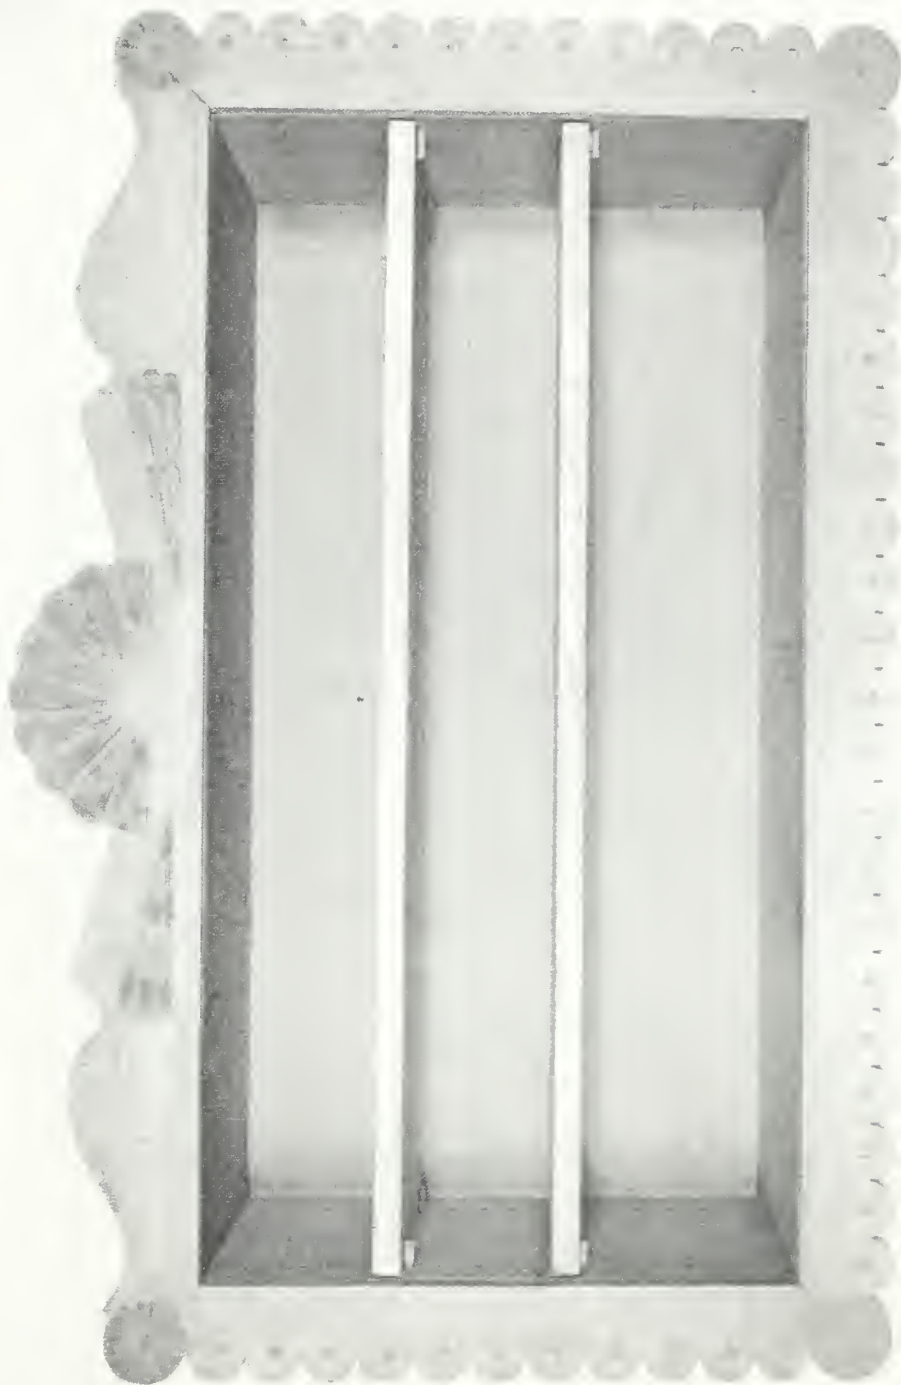
48. "Dining Room, Built-in Shelving, South Wall, (Room 102)." 1992,
Photograph by Historic American Buildings Survey, Museum
Collection, Archives, Petrified Forest National Park, Petrified Forest,
Arizona, No. PD-41; HABS: AZ-161-39.

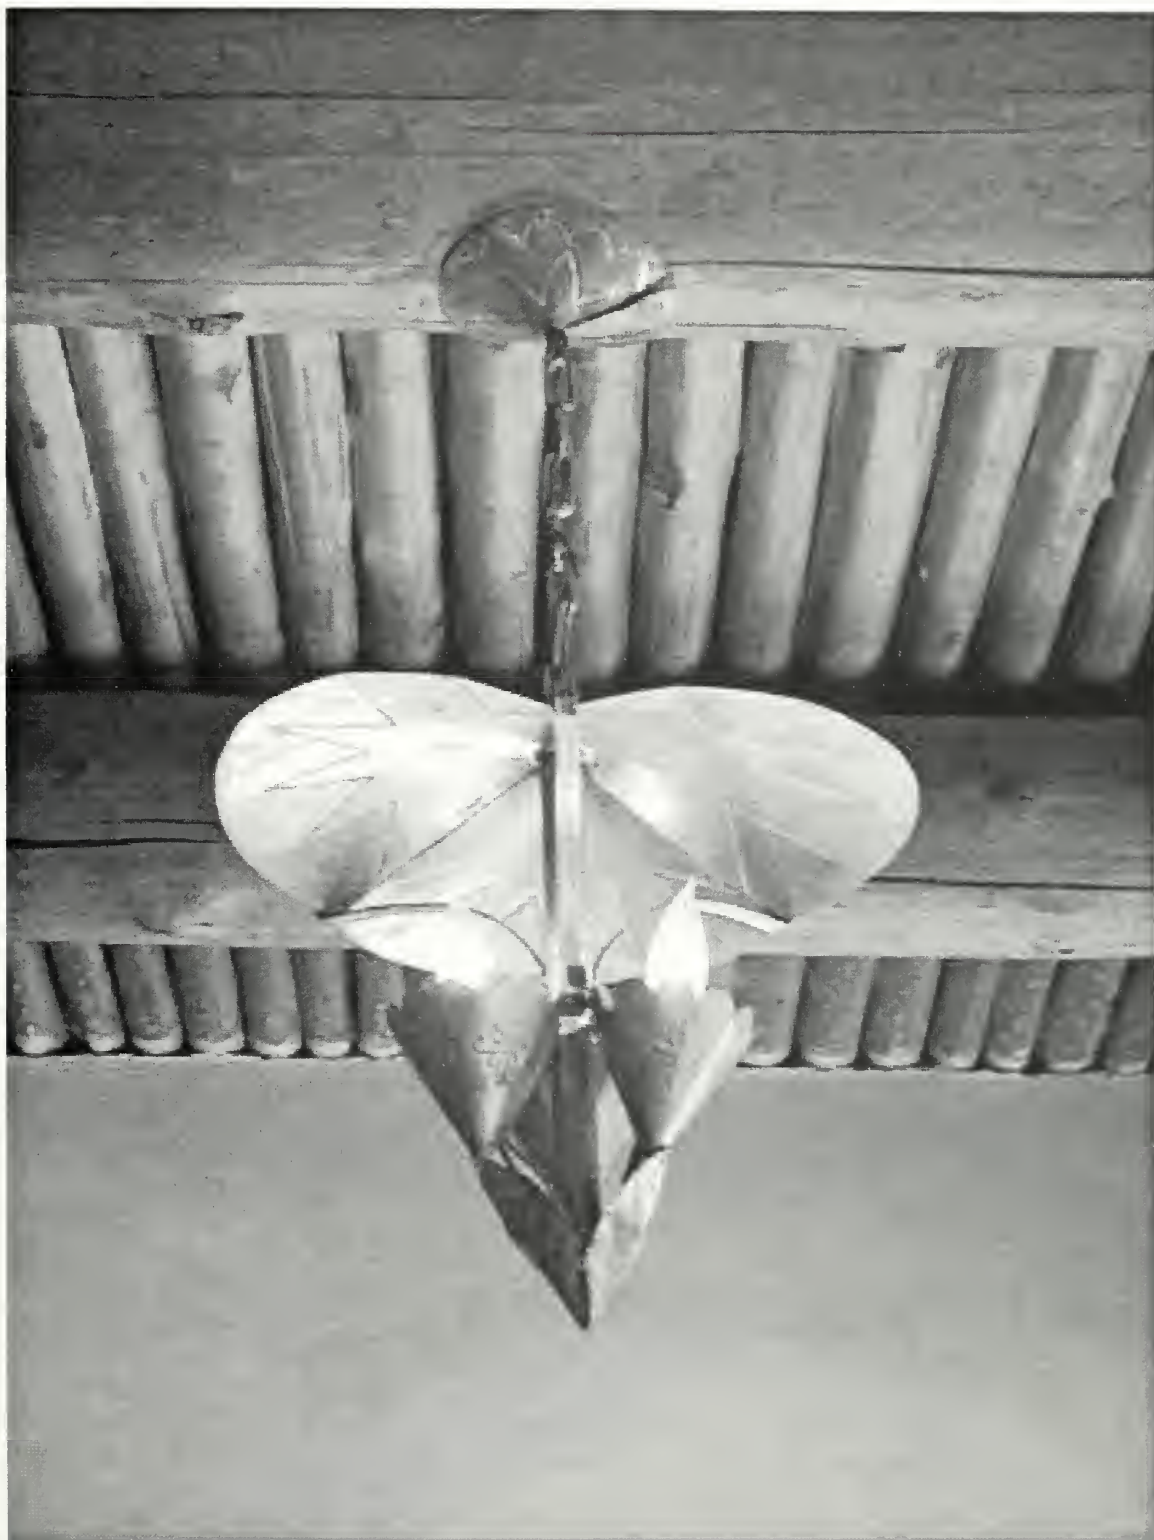
58. "Stamped Tin Chandelier, Lunchroom, (Room 103)." 2002.
Photograph by Laura DeNormandie.

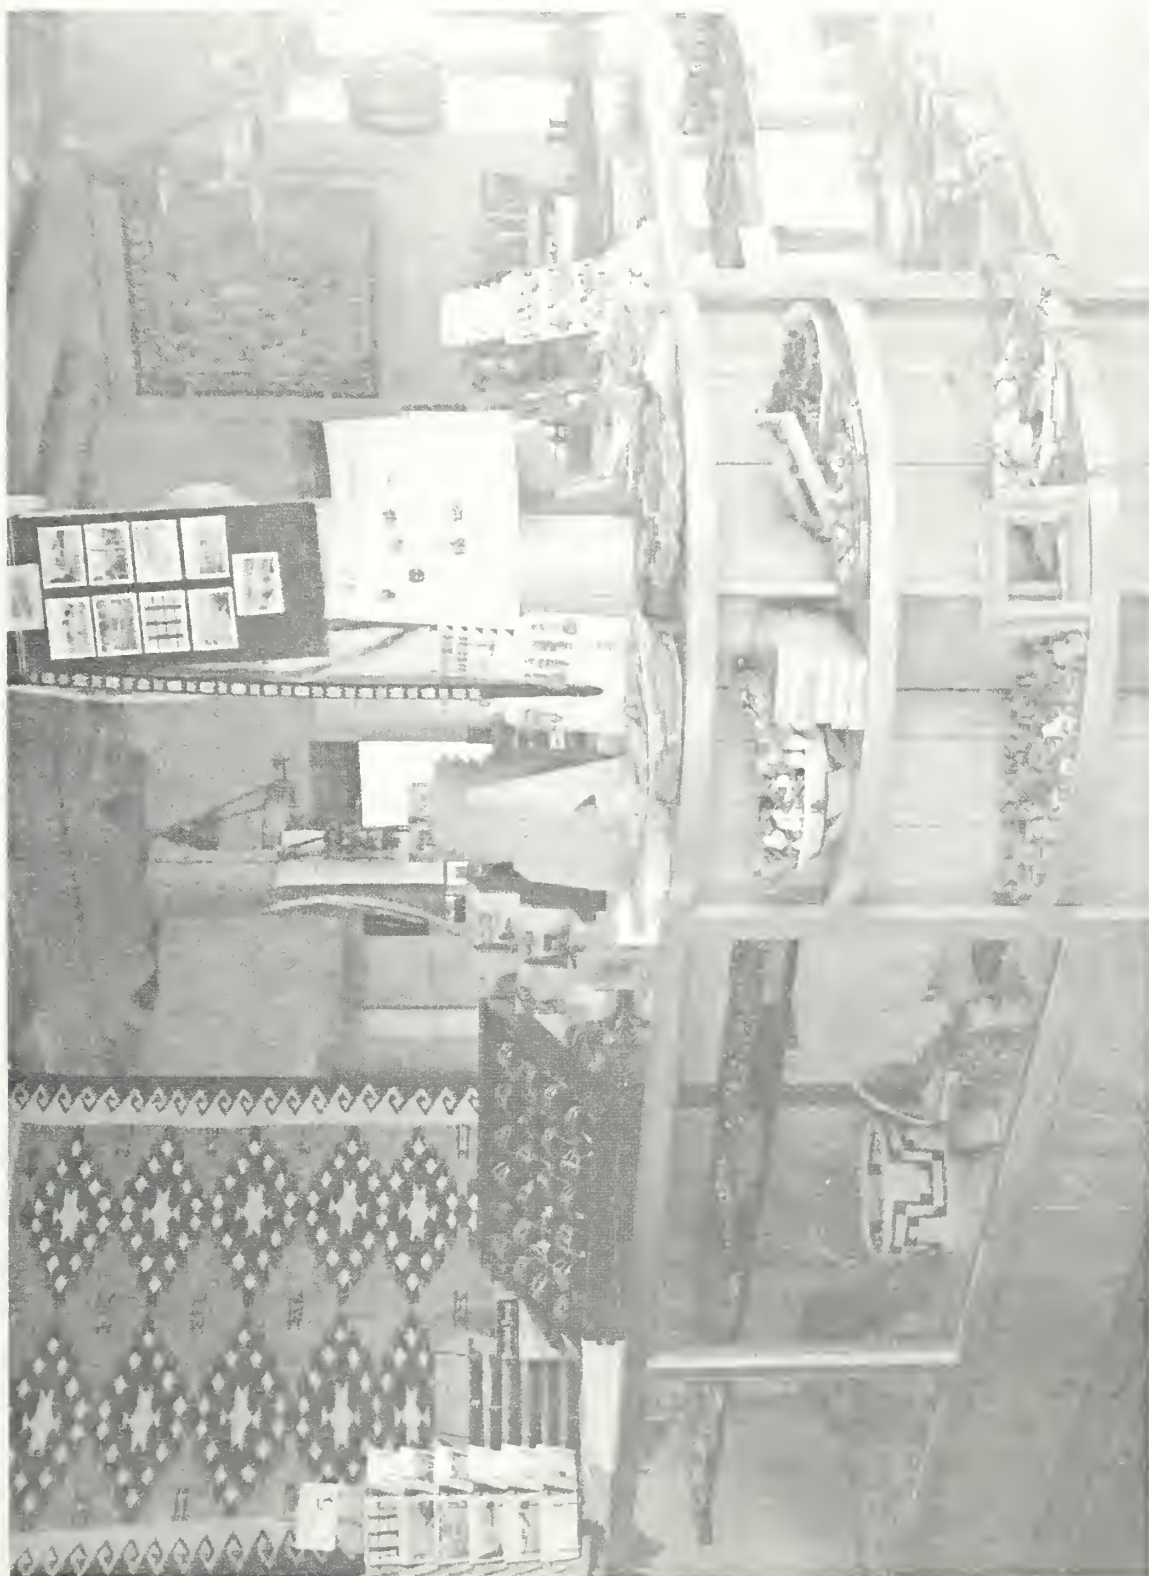
63. "Display Counters, Northeast Column in Foreground, Trading Post Room, (Room 104)." Circa 1940s, Unidentified Photographer, Museum Collection, Archives, Petrified Forest National Park, Petrified Forest, Arizona, Negative No. 741, PEFO CAT. # 20750.
